**UPPER PATUXENT RIVER WATERSHED RESTORATION ACTION STRATEGY (WRAS)  
FORM 1 -- Catchment Information**

Subwatershed: Bear Branch

**UPPER PATUXENT RIVER WATERSHED RESTORATION ACTION STRATEGY (WRAS)  
FORM 2 -- Site Information**

Site Name: Lowes Home Improvement Center Address: 14398 Baltimore Avenue

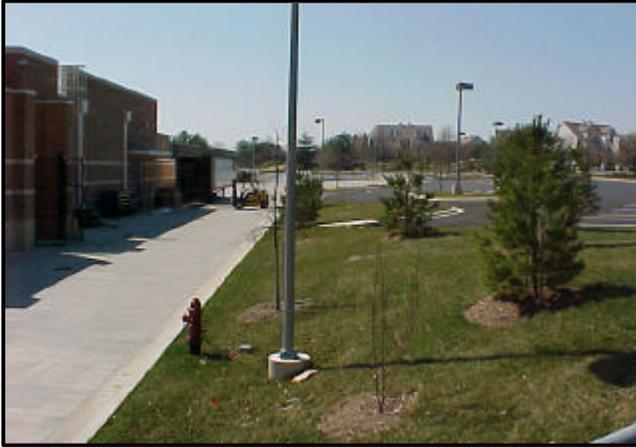
- No. 414 Description: looking south at west (back) side of building
- No. 415 Description: looking east at north side of building
- No. 416 Description: looking north at east (front) side of building
- No. 417 Description: looking south at east (front) side of building
- No. 418 Description: looking west at north side of building
- No. 419 Description: looking north at west (back) side of building
- No. \_\_\_\_\_ Description: \_\_\_\_\_

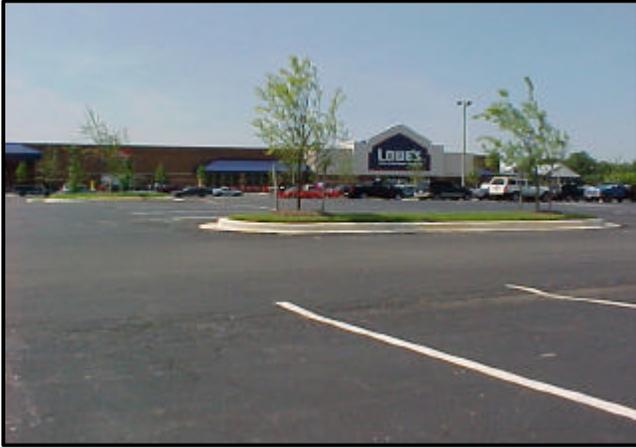
871

No. <u>871</u>	Description: <u>looking north at front of building</u>
No. <u>872</u>	Description: <u>looking northeast at back of building</u>
No. _____	Description: _____

**Comments** Roof drains have downspouts that connect directly to storm drain. Connection could be broken.

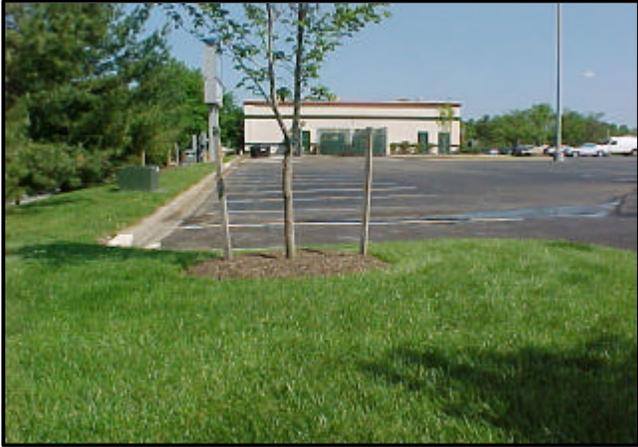
873

No. <u>873</u>	Description: <u>looking east</u>
No. <u>874</u>	Description: <u>looking west</u>
No. _____	Description: _____

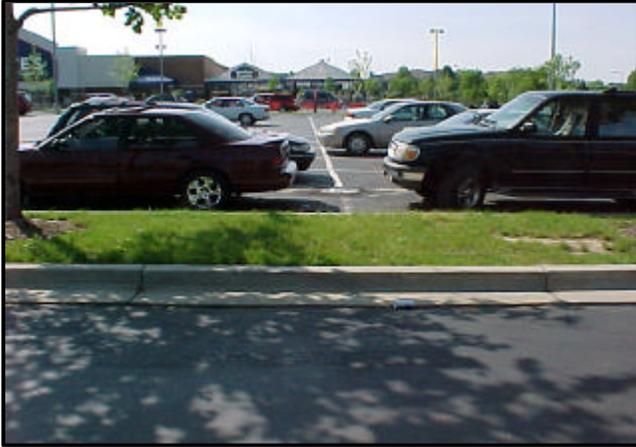
875

No. <u>875</u>	Description: <u>looking west</u>
No. <u>876</u>	Description: <u>looking east</u>
No. _____	Description: _____

**Comments** IMP treats 99% of the drainage area  
IMP size = 2,871 sq ft  
 \_\_\_\_\_  
 \_\_\_\_\_  
 \_\_\_\_\_  
 \_\_\_\_\_  
 \_\_\_\_\_  
 \_\_\_\_\_

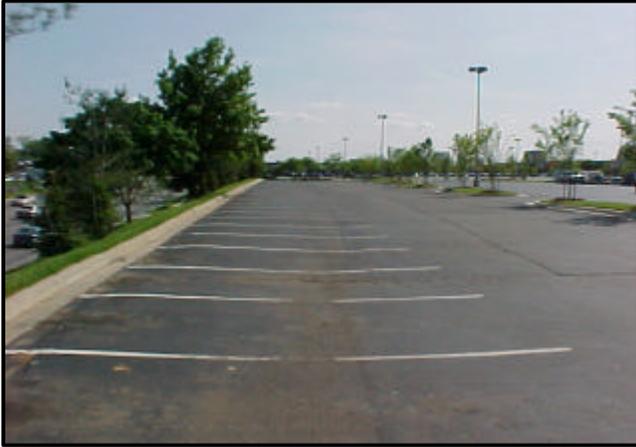
877

No. <u>877</u>	Description: <u>looking south</u>
No. <u>878</u>	Description: <u>looking north</u>
No. _____	Description: _____

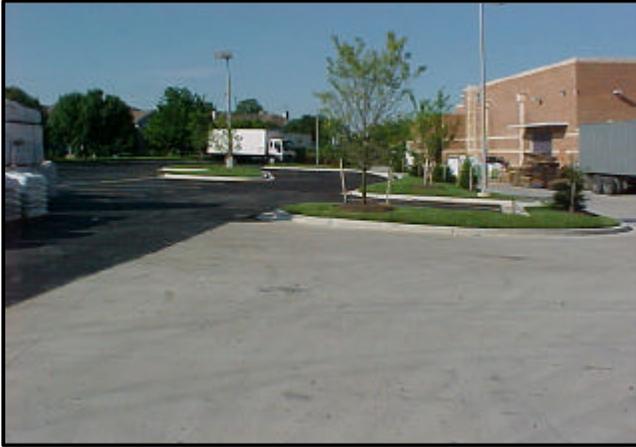
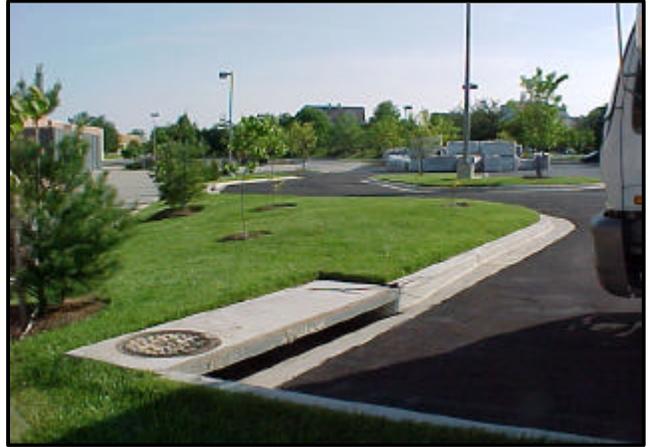
**Comments** A speed bump will be used to direct flow. Runoff can be treated within existing grassed areas. If additional treatment area is needed, pavement can be removed and replaced with bioretention area.  
IMP treats 89% of the drainage area  
IMP size = 4,426 sq ft  
 \_\_\_\_\_  
 \_\_\_\_\_  
 \_\_\_\_\_

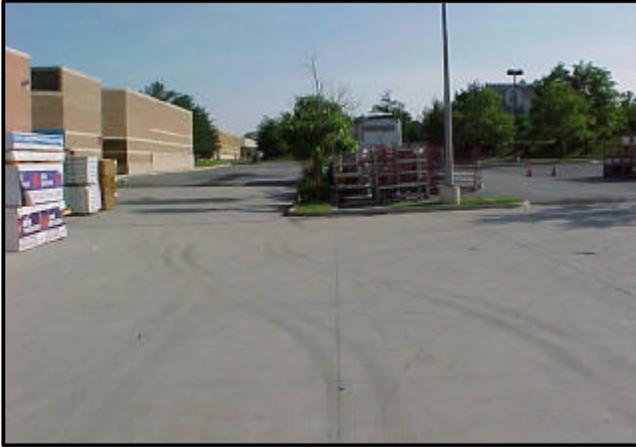
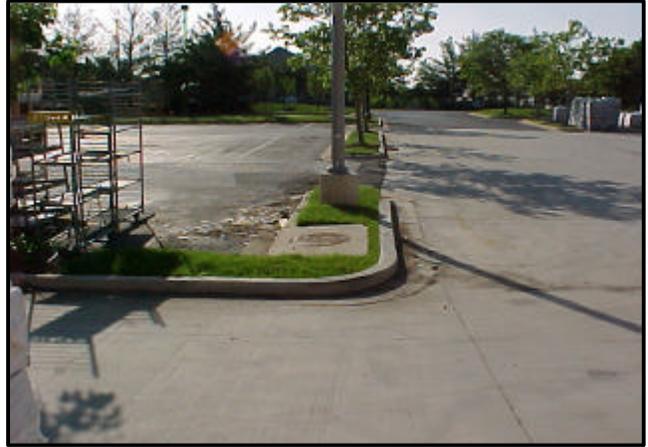
**Comments** A speed bump will be used to direct flow. Runoff can be treated within existing grassed areas. If additional treatment area is needed, pavement can be removed and replaced with bioretention area.  
IMP treats 51% of the drainage area  
IMP size = 5,867 sq ft  
 \_\_\_\_\_  
 \_\_\_\_\_  
 \_\_\_\_\_
